Restaurant Survives Grease Fire Because Factory Built Exhaust Duct Did Its Job

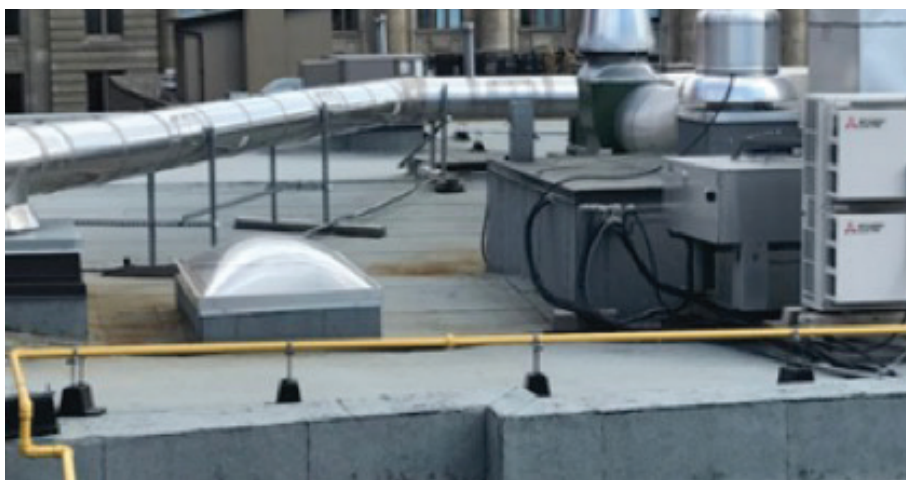
While the exterior of dual wall duct looked pretty much the same as it had the day it was installed, post-fire inspection of the interior wall revealed evidence of a fire that likely reached temperatures of 1000°F (540°C) or higher.

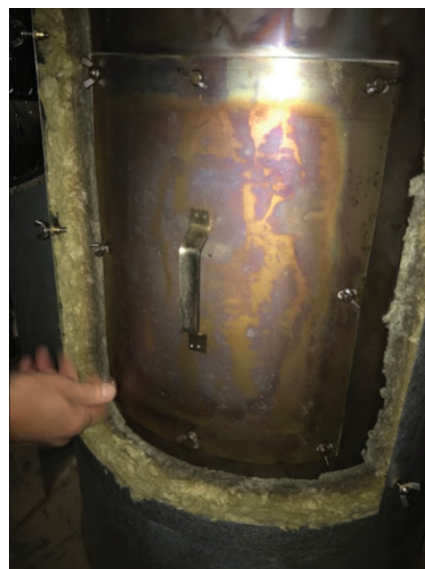
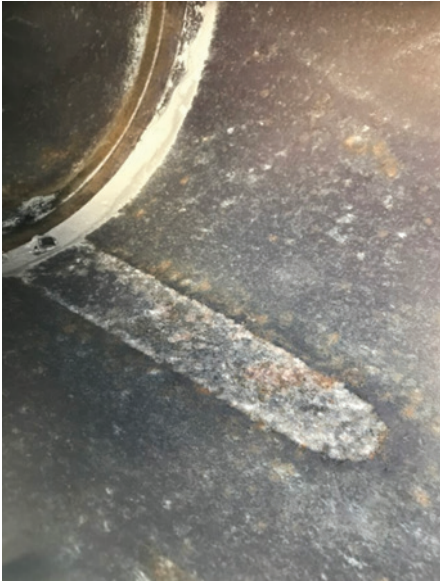
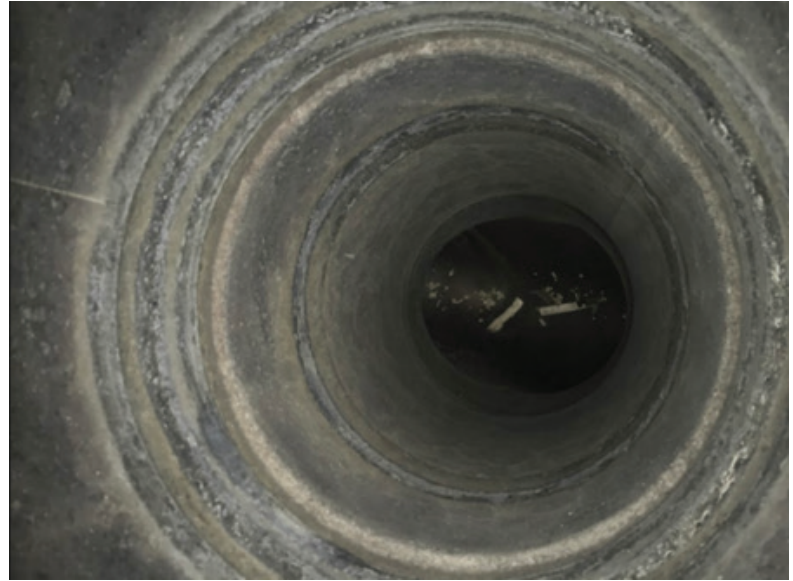
Mr. Wright was asked to inspect the duct, along with the installing contractor, shortly after the fire occurred. He later prepared a report for the owner, complete with a series of photos taken at the site. The photos reveal a duct system that was perfectly intact, except for discoloration of the inner wall and soot and residue from burned grease on the duct interior. The entire length of the exterior duct wall, from fireplace hood to rooftop, showed no sign of fire.

Looking down into the disassembled chimney, however, Mr. Wright and the contractor saw plenty of evidence of heat, fire and grease accumulation. Not only was the interior of the inner wall blackened by soot from smoke, a speckled white residue showed where puddles of grease had accumulated and then burned off during the fire. Wood-fired ovens, though immensely popular for the rustic flavors they produce, require the owners to commit to a level of consistent maintenance. These and all other solid fuel burning grills and ovens are especially vulnerable to creosote and grease build-up and require weekly inspection and regular cleaning per NFPA 96.
